Two Structures, Two Treatments

A restored farmhouse receives a regionally inspired addition

BEST REMODEL

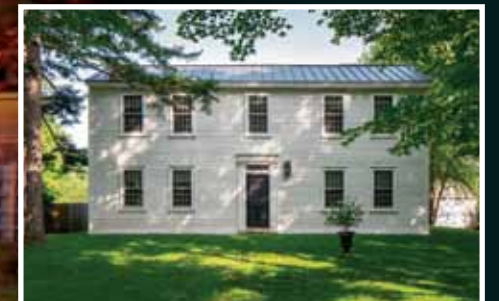
Restoration motivation. After years spent admiring this 18th-century house, the clients purchased the property, and have retained the original structure's facade.

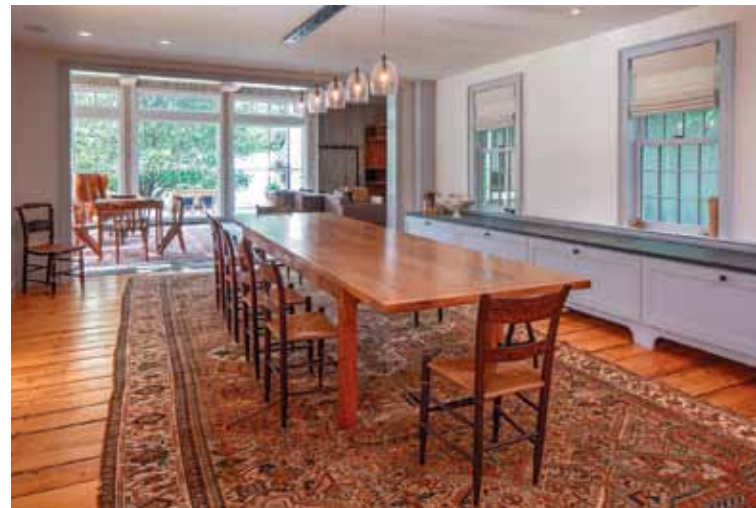
Shifty sideboard. To disguise the sag of the 230-year-old floor—nearly 3 in. out of level in a span of 15 ft.—the builder made a base with different-length legs. The gap between the bottom rail and floor varies along the length of the piece, but because the shadowline masks the incremental height differences, the eye doesn't pick up on it.

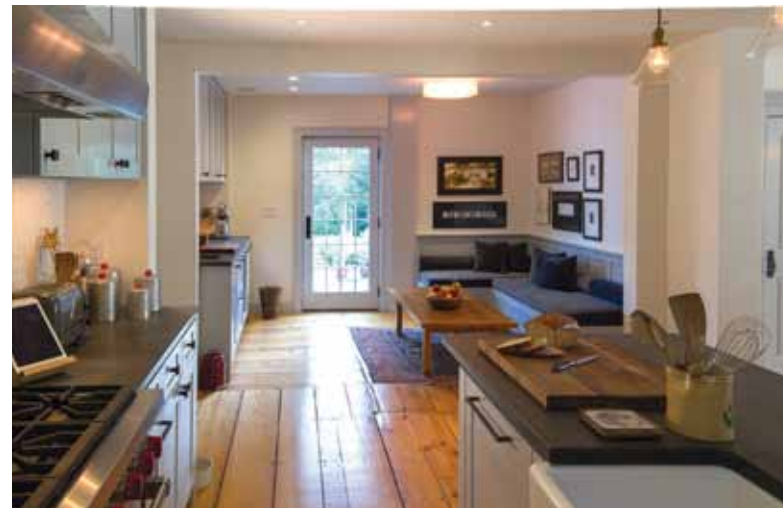
Strategic arrangement. The kitchen is divided into separate but connected rooms and storage areas. There's a central main space, which is devoid of large appliances, as well as a lounge/bar area with seating, a full-size pantry that houses a fridge and freezer, and a dry-goods pantry.

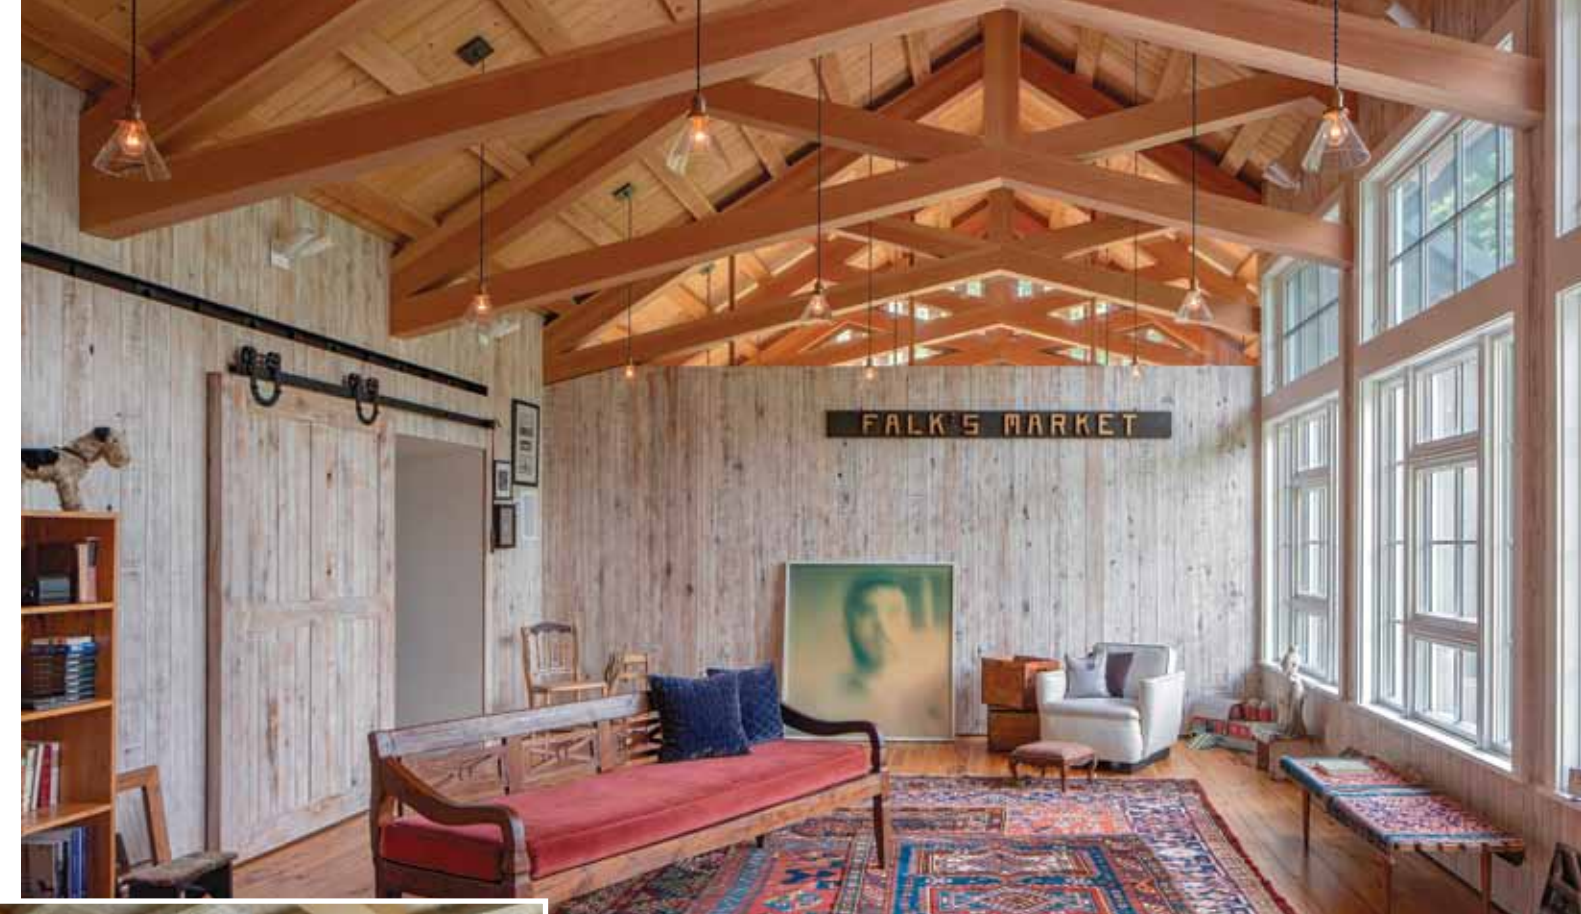
A space to create. The orientation of the building maximizes desirable northern light in the artist's studio, where the intricacies of the trusswork (see "Customizing trusses," p. 64) are on full display.

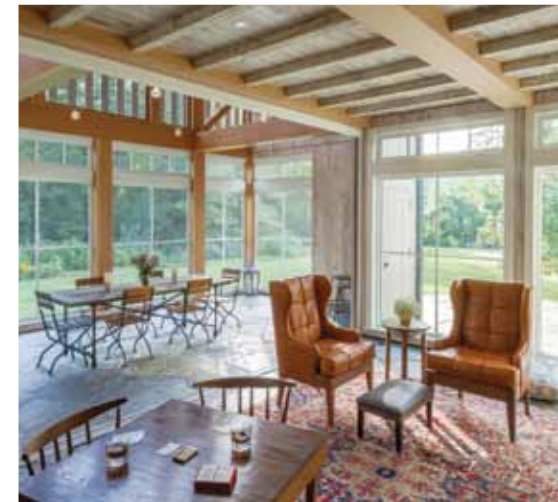
Rustic respite. LVLs wrapped in chestnut warm the partially conditioned interiors, which are separated from the screened porch by a NanaWall that disappears from view when open.

The trusswork includes two webs infilled with glass to separate the conditioned space from the unconditioned screened porch (see p. 63, top photo). The glass was cut to be sandwiched between the finished trusses.

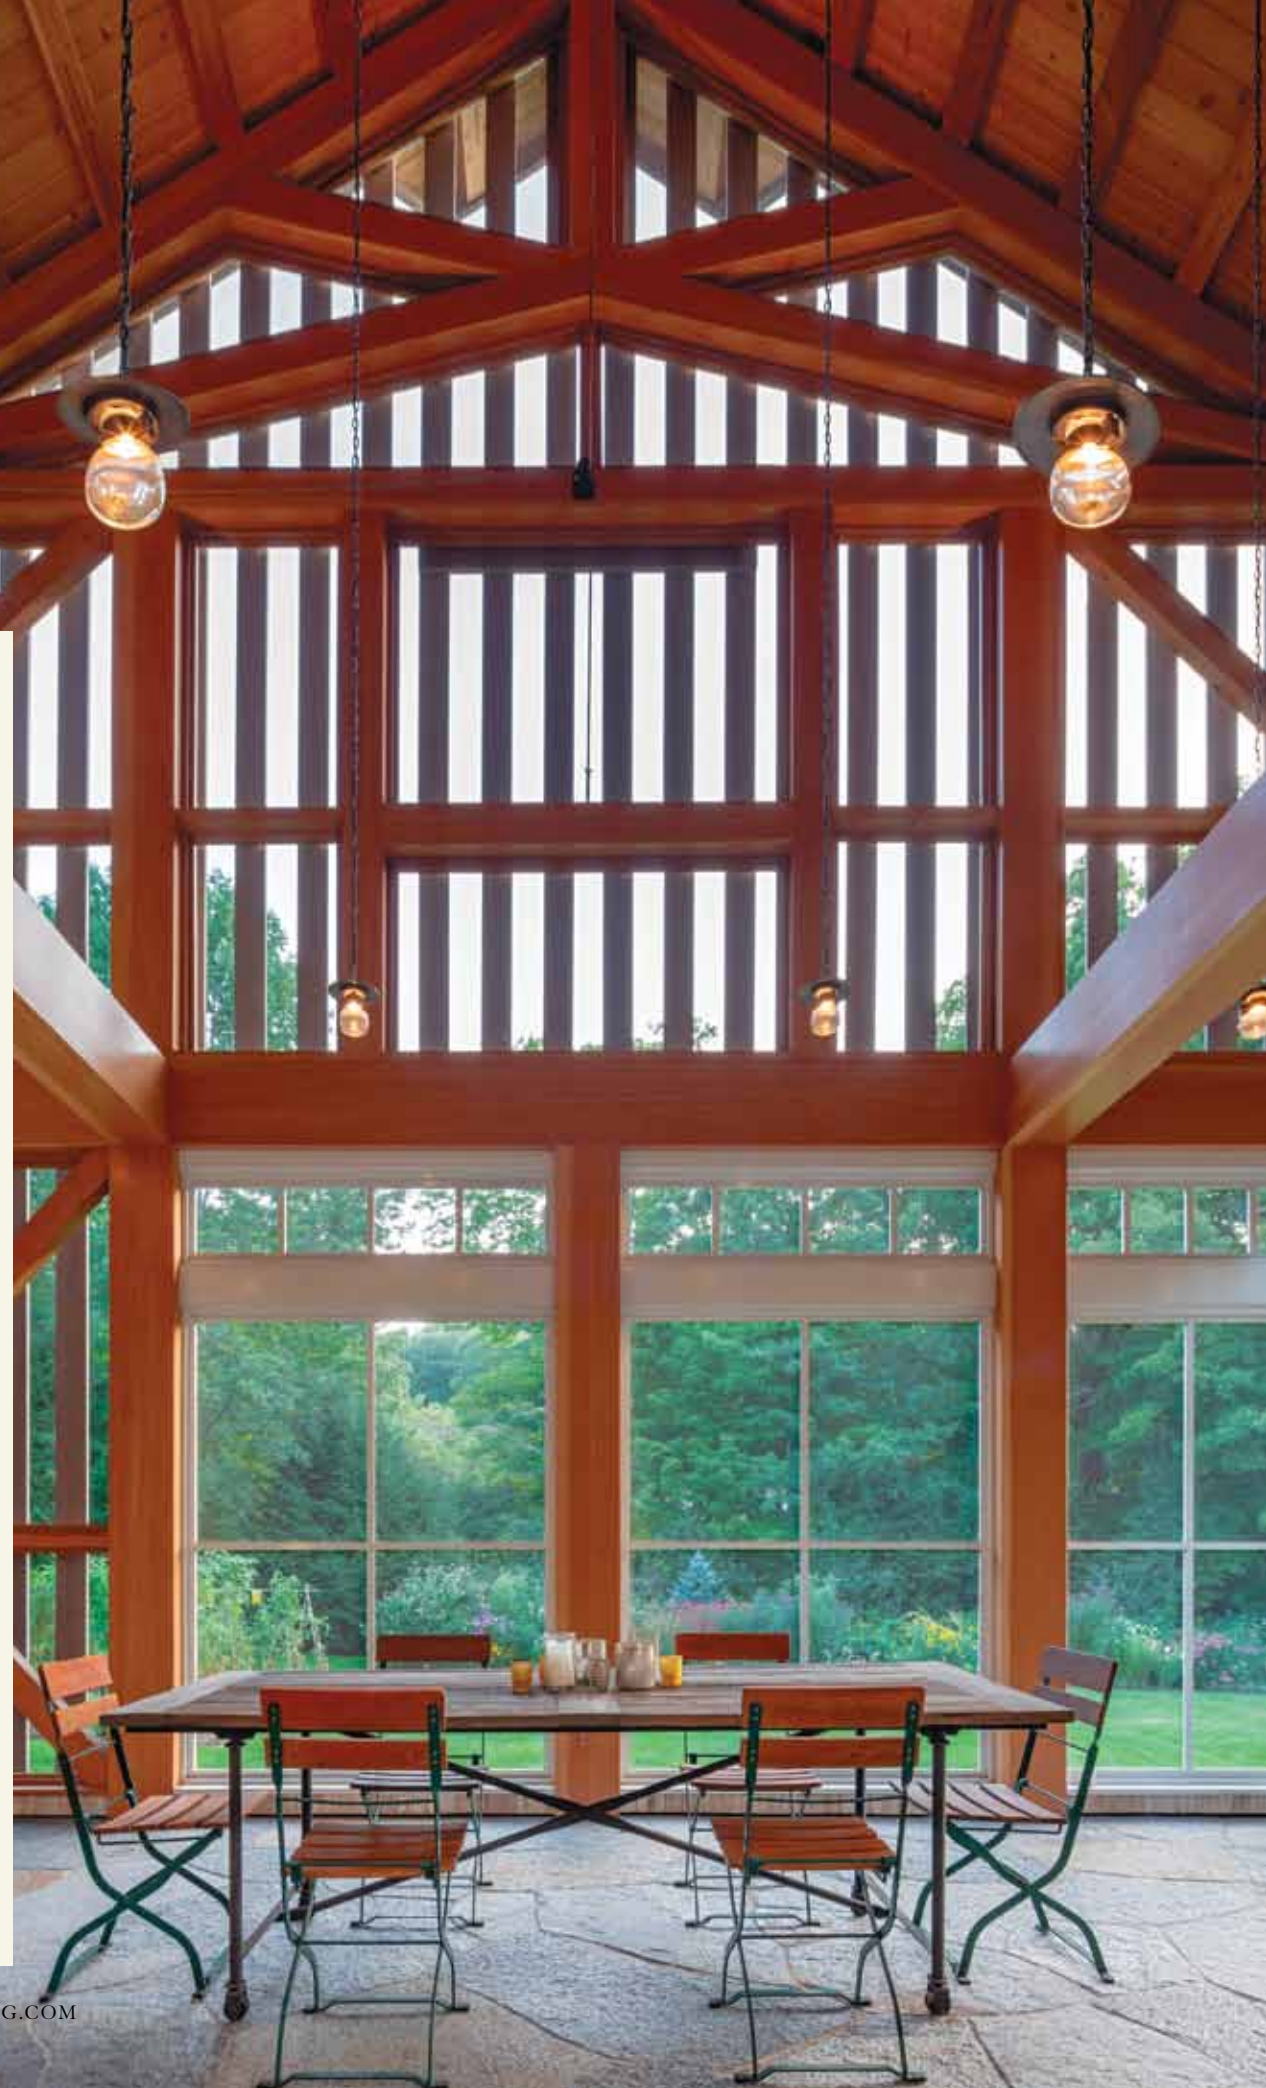
CUSTOMIZING TRUSSES

After the rough truss framing went up, the builder wrapped every surface with the highest-grade quartersawn clear Douglas fir, chosen for its consistent grain.

He used 3/4-in.-thick 1x12s for the finish wood—ripping miters at every corner—to create the look of solid timber and left an 1/8-in. gap on each side of the trusses for expansion/contraction to protect the mitered corners from popping apart with humidity.

The same approach was used on the opposite end of the room, with the added complication of a chimney running through the assembly.

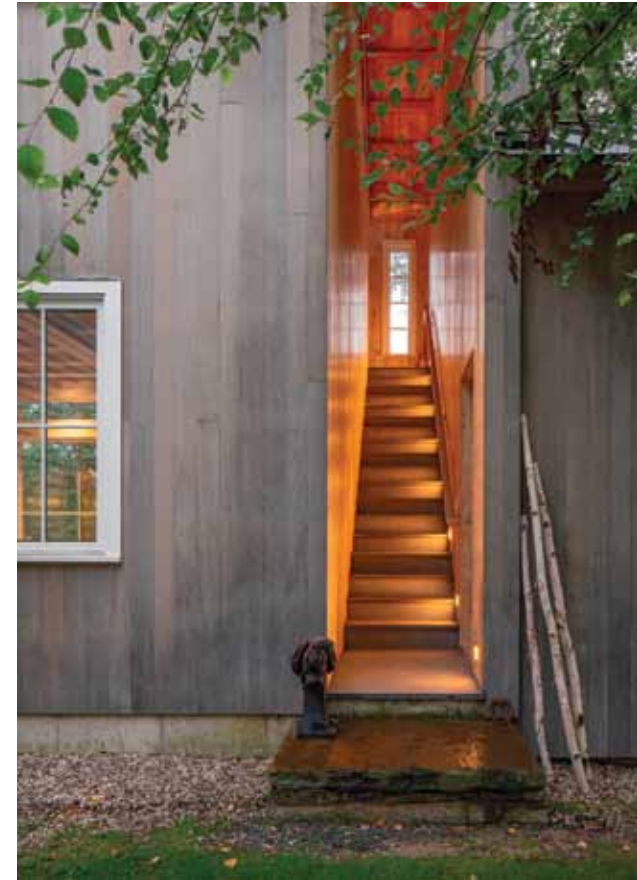
Creating a slot stair. A 38-in.-wide “slot” stair in the studio separates an older restored barn from the new structure. Because *Galaxy Schist*, a locally sourced stone, was used for the landings, treads, and risers, the stairs needed to be engineered to handle the added weight. The stairwell is clad in whitewashed tongue-and-groove chestnut finished with rubbed urethane.
